**BLACKSTONE RIVER BASIN
WORCESTER, MASSACHUSETTS**

**QUINSIGAMOND POND DAM
MA 00139**

**PHASE I INSPECTION REPORT
NATIONAL DAM INSPECTION PROGRAM**

AUGUST 1978

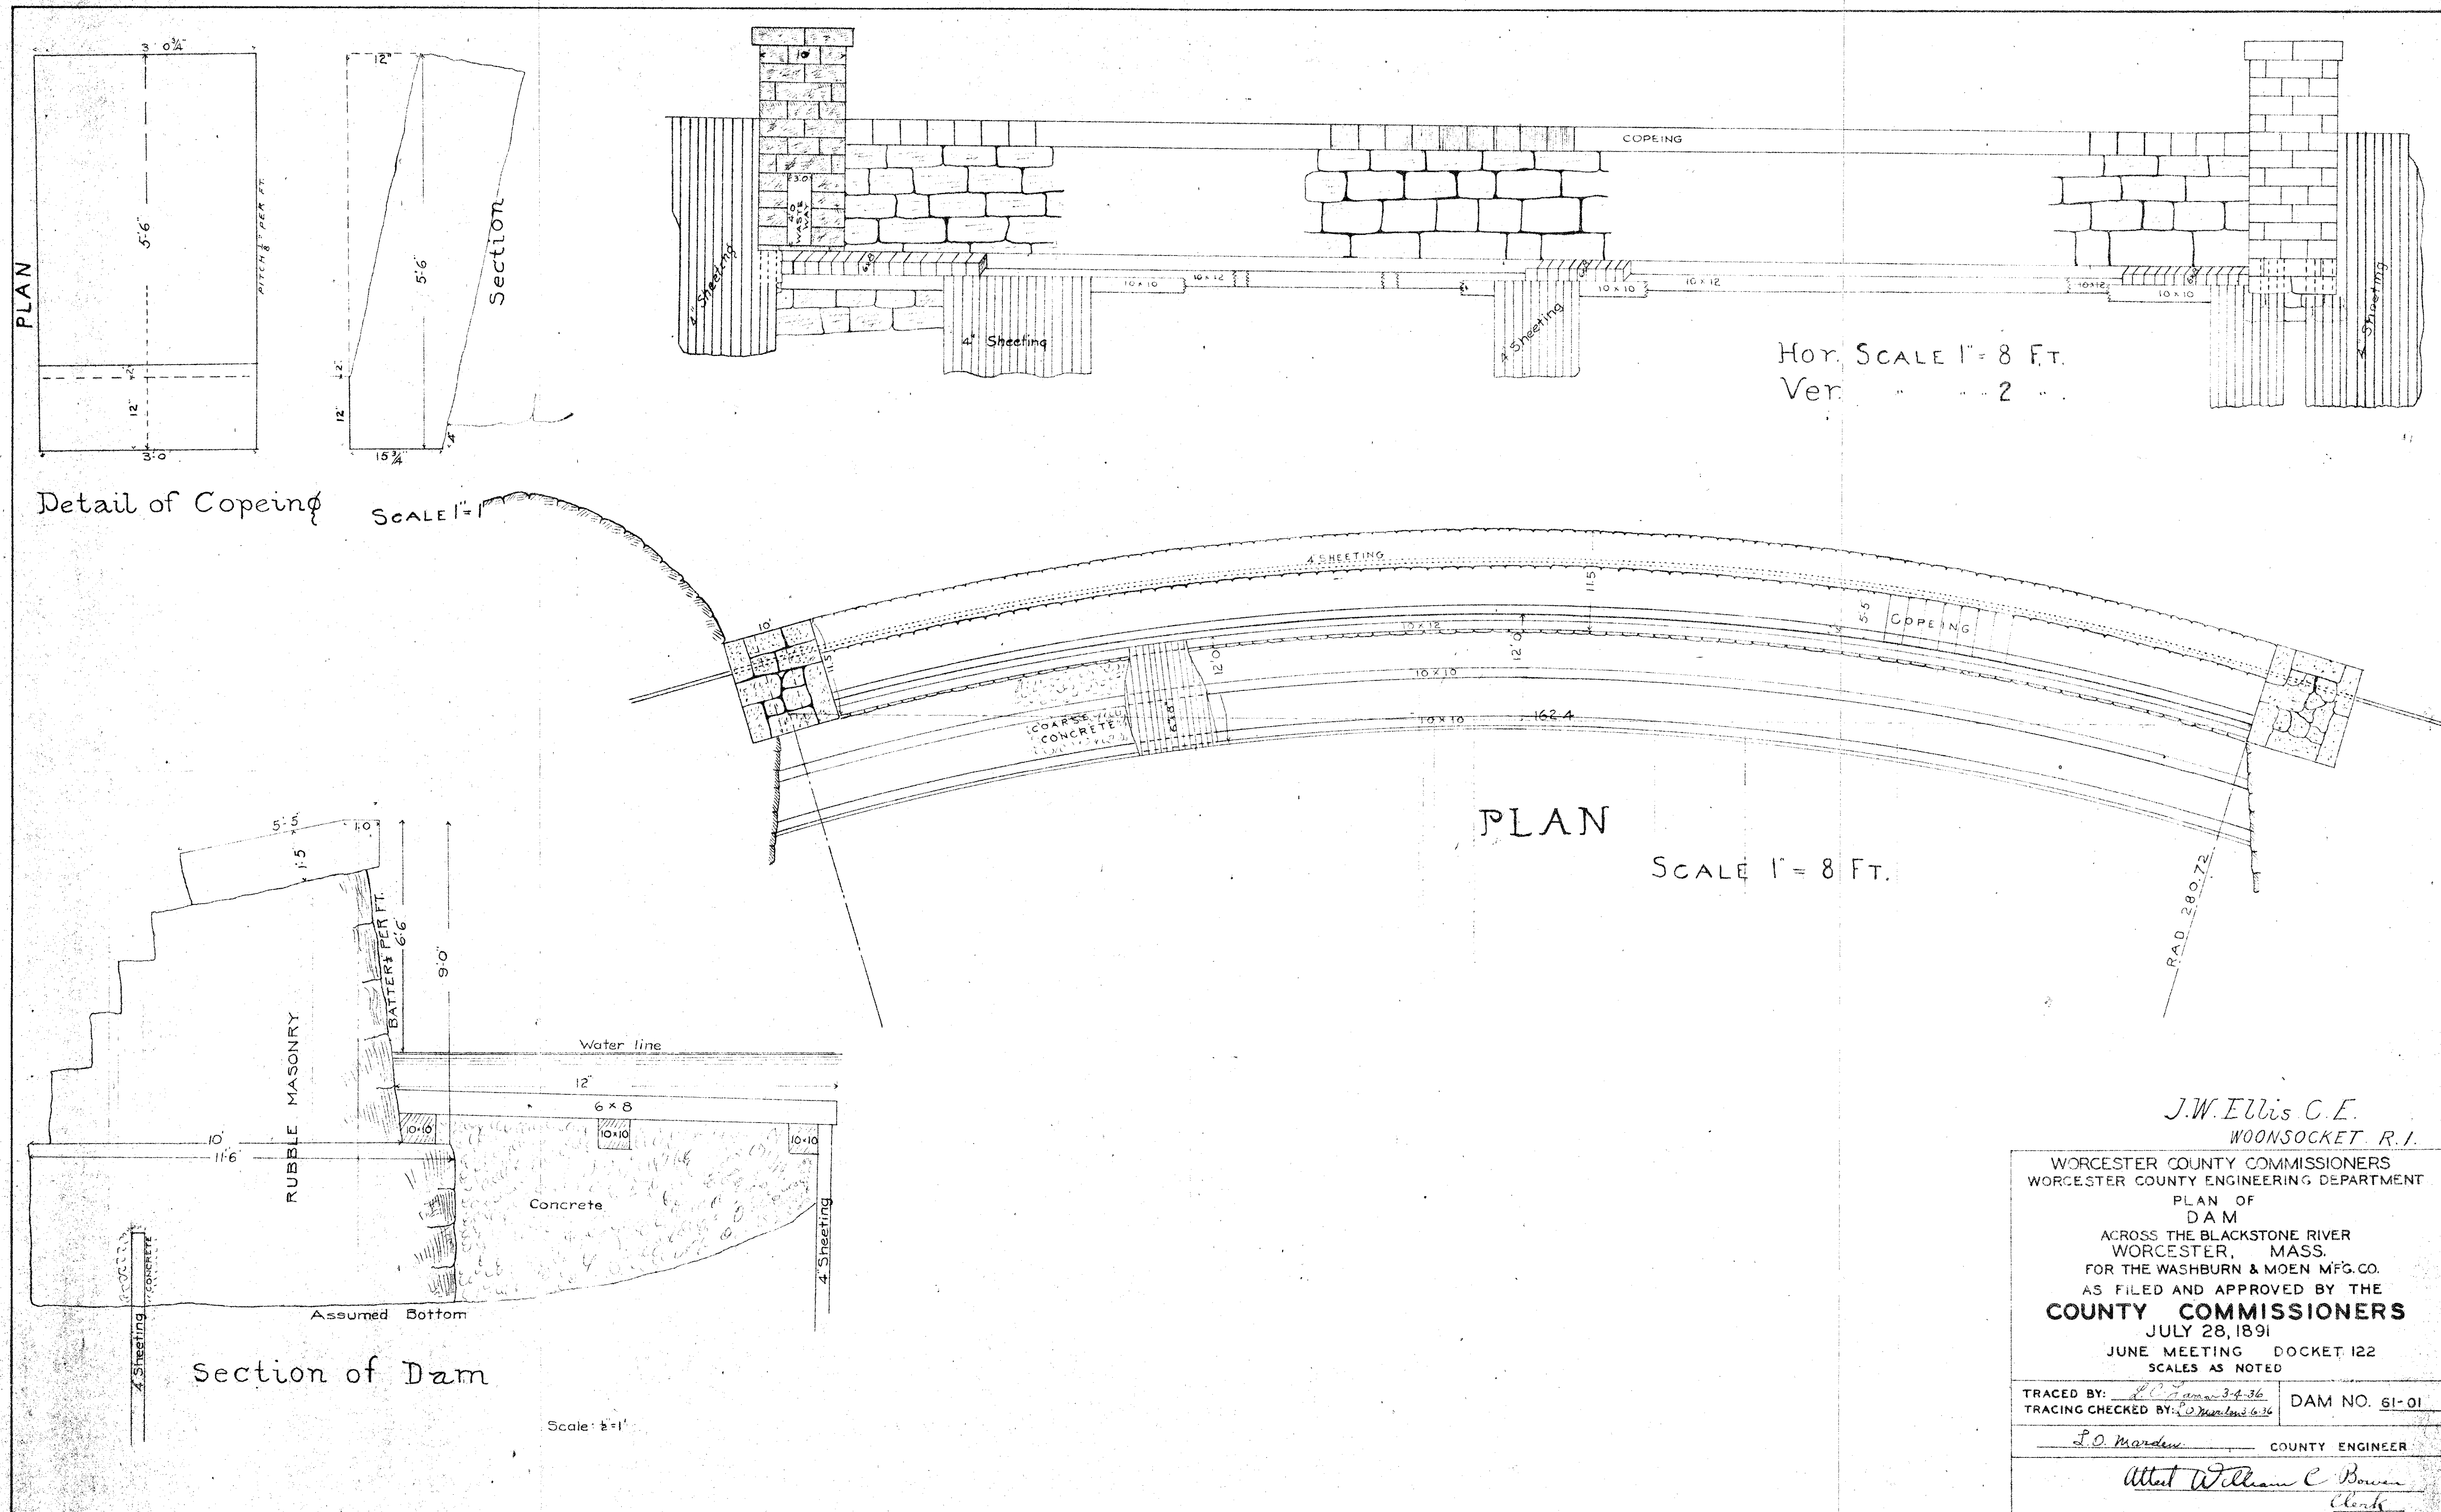
WORCESTER COUNTY COMMISSIONERS
WORCESTER COUNTY ENGINEERING DEPARTMENT
PLAN OF
DAM
ACROSS THE BLACKSTONE RIVER
WORCESTER, MASS.
FOR THE WASHBURN & MOEN MFG.CO.
AS FILED AND APPROVED BY THE
COUNTY COMMISSIONERS
JULY 28, 1891
JUNE MEETING DOCKET 122
SCALES AS NOTED

- 2.1 General. The only plans, specifications, or computations available from the Owner or State or County offices relative to the design, construction or repair of this dam is a "Plan of Dam Across the Blackstone River" filed in July 28, 1891. This plan shows details of the spillway weir, the concrete apron at the downstream toe, and two cutoff walls. A copy of this plan is included in Figure B-3 in Appendix B.
